Comparative Study of Corrosion Performance of HVOF-Sprayed Coatings Produced Using Conventional and Suspension WC-Co Feedstock

Ahmed, R, Vourlias, G, Algoburi, A, Vogiatzis, C, Chaliampalias, D, Skolianos, S, Berger, LM, Paul, S, Faisal, NH, Toma, FL, Al-Anazi, NM & Goosen, MFA 2018, 'Comparative Study of Corrosion Performance of HVOF-Sprayed Coatings Produced Using Conventional and Suspension WC-Co Feedstock', *Journal of Thermal Spray Technology*, pp. 1-15. <https://doi.org/10.1007/s11666-018-0775-2>

Journal of Thermal Spray Technology

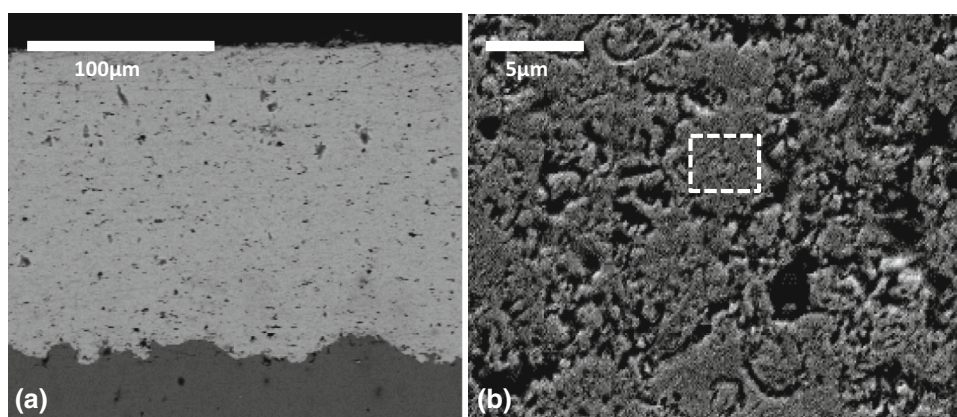
The average coating thickness before corrosion test was $134 \text{ }\mu\text{m}$. No cracks were found but the coating cross section is characterized by many pores and lamellae formations (Fig. 1a). On the polished surface, numerous large pores with diameter up to $2.5 \text{ }\mu\text{m}$ were observed (Fig. 1b). EDS analysis on the denoted surface area revealed that it contains 25 at.% Co and 75 at.% W. Carbon was not detectable from the EDS analyzer because the EDS detector had Be window which absorbs low-energy x-rays; thus, only elements with atomic number greater than carbon were detectable.

Fig. 1 Cross-sectional (a) and (b) polished plane-view SEM micrograph of the as-sprayed S-HVOF sample

and some WC and W_2C (Ref 22–24). Thus, the nature of this amorphous/nanocrystalline phase is currently not known. The significant difference between the S-HVOF coating (higher corrosion current i_{corr} —Table 3) compared with the other coatings can be explained somewhat by the classical corrosion theory where nanostructured materials accelerate any electrochemical process by forming more local micro-electrochemical cells across higher density of grain boundaries and also by the relatively higher pore content (Fig. 1 and 2) (Ref 28, 29).

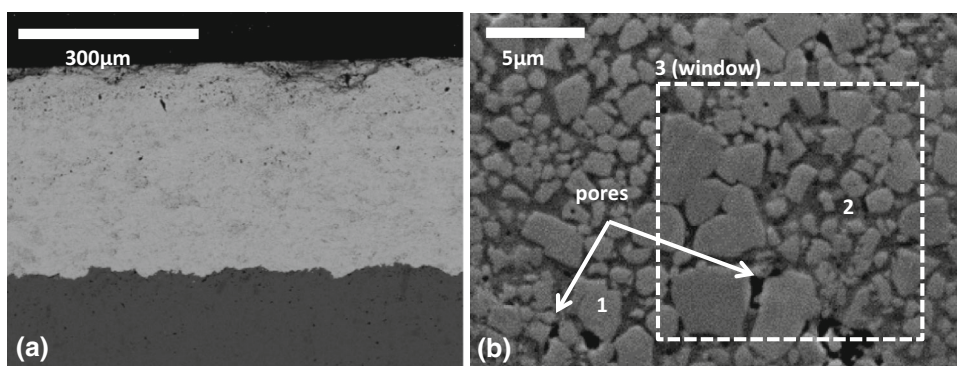
The average coating thickness before corrosion was $326 \text{ }\mu\text{m}$. No cracks or large connected pores were found. Its cross section is characterized by less pores compared with S-HVOF and lamellae formations (Fig. 2a) which form longitudinal dark formations in S-HVOF coatings. The polished surface morphology is composed by characteristic angular WC grains (light areas) embedded in a Co-

Fig. 2 Cross-sectional (a) and (b) polished plane-view SEM micrograph of the as-sprayed HVOF-JK sample

W matrix (darker areas) (Fig. 2b). This was verified by the EDS analysis denoted in Fig. 2(b) which revealed that area 1 is mainly composed of W while area 2 is composed of 28 at.% Co and 72 at.% W. The denoted window in Fig. 2(b) was found to contain 90 at.% W and 10 at.% Co in total. The number of large pores is significantly less compared with the S-HVOF coating.

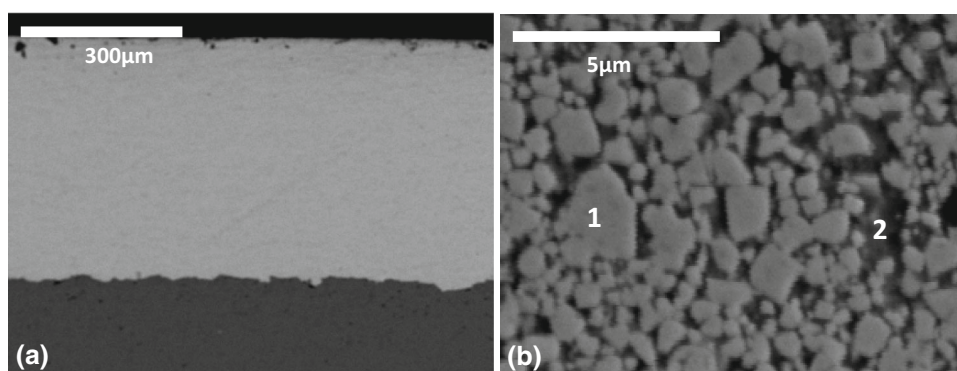
Fig. 3 Cross-sectional (a) and (b) polished plane-view SEM micrograph of the as-sprayed HVOF-JP sample

The average coating thickness before corrosion was 383 μm . No cracks or large connected pores were found. Its cross section shows relatively lower pore content between the three

coatings (Fig. 3a). The pores are mainly restricted to the upper region of the coating, while lamellae formations are hardly observed. The polished surface morphology is similar to HVOF-JK with micron-sized WC particles embedded in Co-W matrix (Fig. 3b). EDS results on the denoted areas in Fig. 3(b) revealed that area 1 is mainly composed by W while area 2 is composed of 63 at.% Co and 37 at.% W.

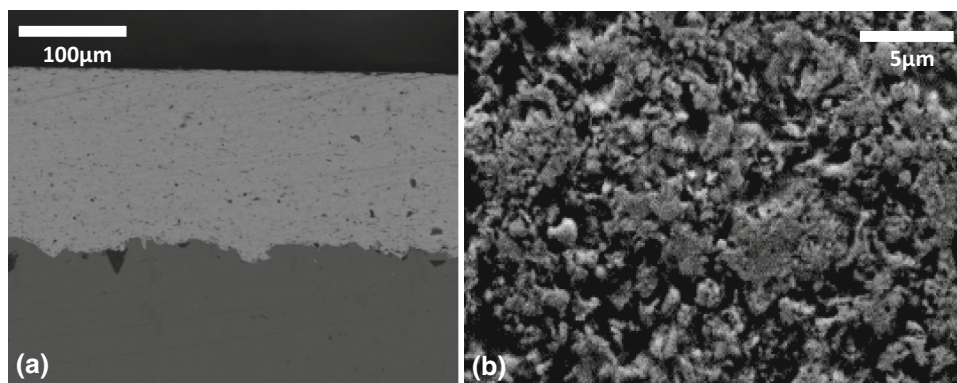
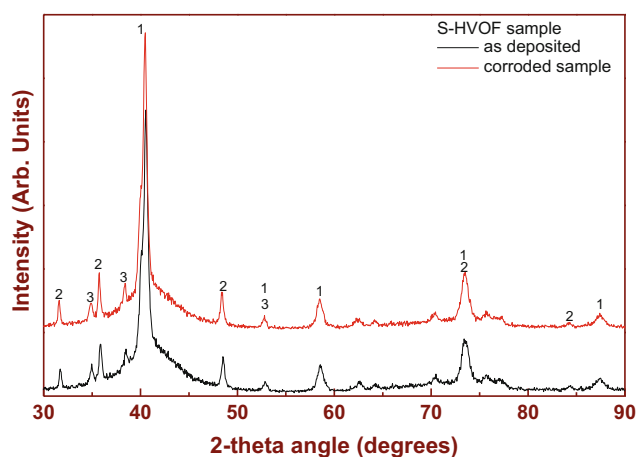
After potentiodynamic measurements, the thickness of the corroded S-HVOF coating (Fig. 4a) still corresponds to the

Fig. 4 Cross-sectional (a) and plane-view (b) SEM micrograph of the corroded S-HVOF sample

as-sprayed state (Fig. 1a). However, in the plane-view SEM micrograph (Fig. 4b), the surface roughness was found to increase as more craters are observed to have been formed compared with the as-sprayed state (Fig. 1b). This can be attributed to some material loss due to corrosion. EDS analysis performed on different areas of the surface showed that no corrosion products could be detected.

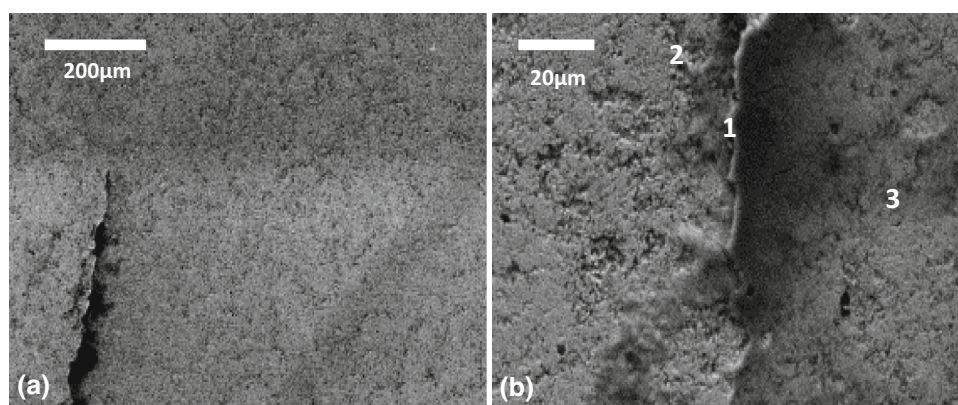
Fig. 6 Plane-view SEM micrographs of the collapsed corroded areas of S-HVOF sample in different magnifications

Table 2 EDS results from the denoted areas in Fig. 6(b). All values are in at.%

Area nr.	O	Na	Cl	Fe	Co	W
1	42.7	2.0	3.6	37.2	1.5	12.9
2	3.7	0	0	0.3	5.9	90.1
3	14.1	0.6	0.3	0.6	4.7	79.7

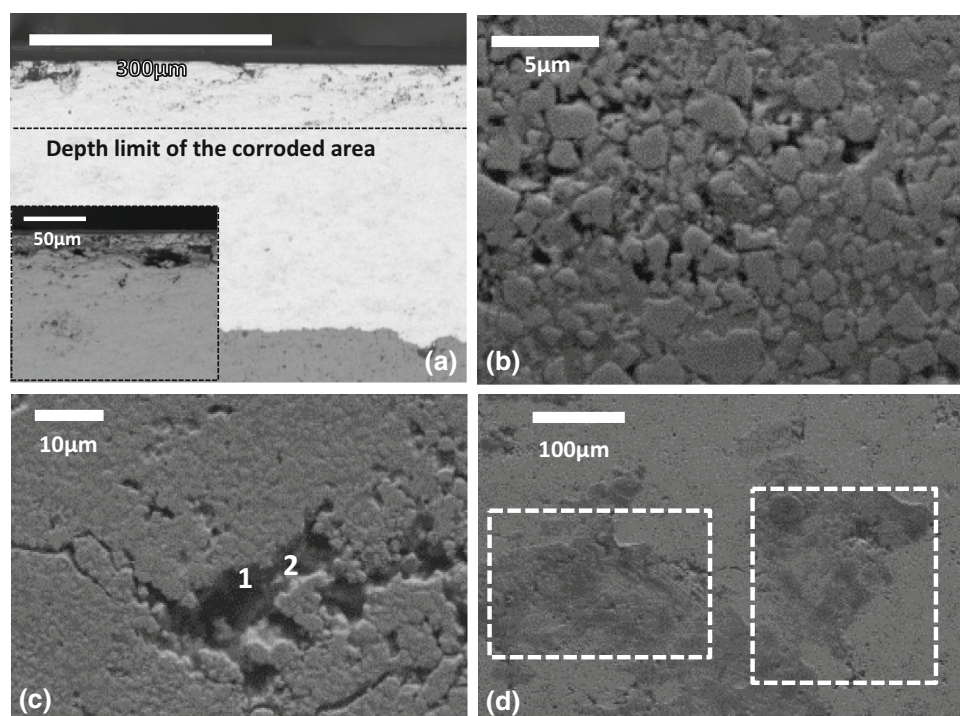
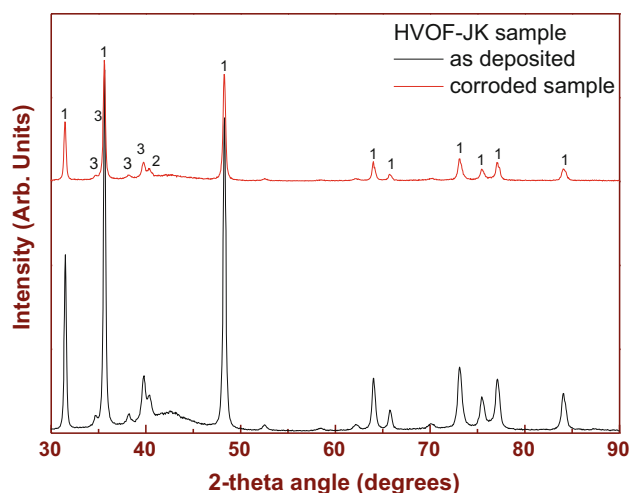
After potentiodynamic measurements, the thickness of the corroded HVOF-JK sample remained nominally stable compared with the as-deposited one in Fig. 2(a) (Fig. 7a). In some areas on the surface, several corroded regions were observed (dark areas at the top coating areas) where the pore network was enlarged by the effect of the corrosive environment, leaving easy path for its penetration from the corrosive agents. Particularly, in these areas the presence of Cl and Na was detected with EDS up to a depth of 80 μm (inset image of Fig. 7a). In the plane-view SEM micrograph (Fig. 7b), numerous craters were observed which in some cases have significant depth (Fig. 7c). The material loss at these areas was extreme as EDS in these craters revealed the existence of Fe (21 at.%, O, 8.5 at.% Na, 43 at.% Cl, 10.5 at.% Fe, 6 at.% Co, 11 at.% W). These deep craters were found at spotted areas and do not characterize the general situation of the sample after corrosion, and hence, they were not found in the cross-sectional image. However, their existence can be considered in order to evaluate the corrosion resistance of HVOF-JK coatings. Finally, some isolated areas were found containing high concentrations of NaCl (denoted areas in Fig. 7d). Their existence is probably the result of some corrosive agent which has adhered on the surface with the help of the preexisting pores.

Fig. 7 Cross-sectional (a) and plane-view SEM micrographs of the corroded HVOF-JK sample (b: general view, c: area with deep craters, d: area with noticeable Na and Cl)

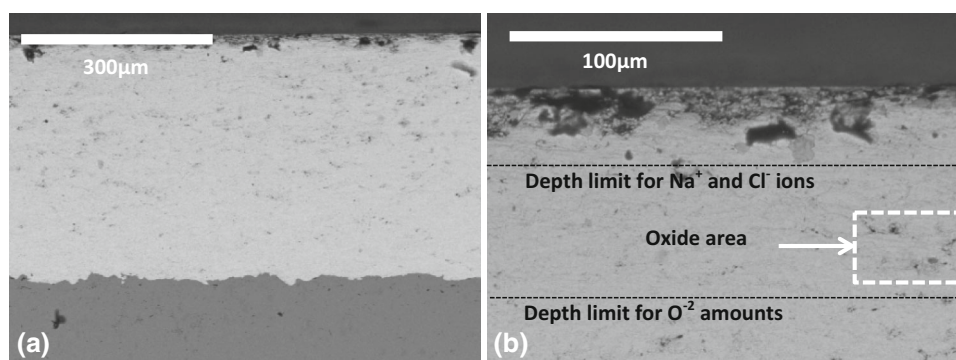
The corroded HVOF-JP sample, similar to the previous samples, maintains its initial thickness after deposition compared with the as-deposited one in Fig. 3(a) (Fig. 9a). EDS analysis performed on the cross section revealed in some cases significant penetration of the corrosion agents

Fig. 9 Cross-sectional SEM micrograph of the corroded HVOF-JP sample (a) and magnification of the surface area (b)

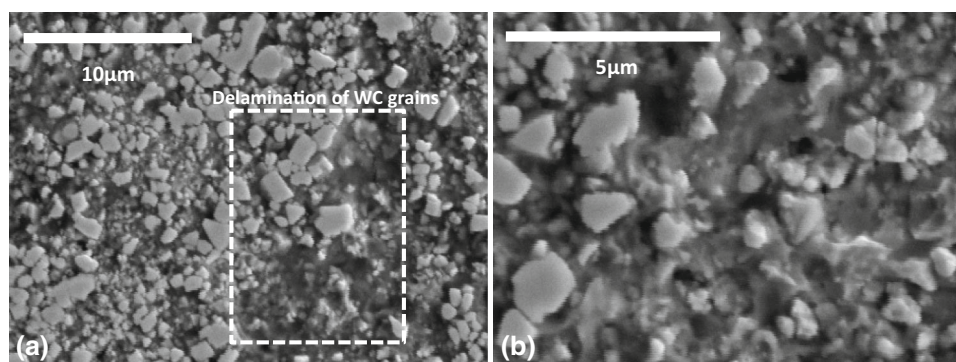
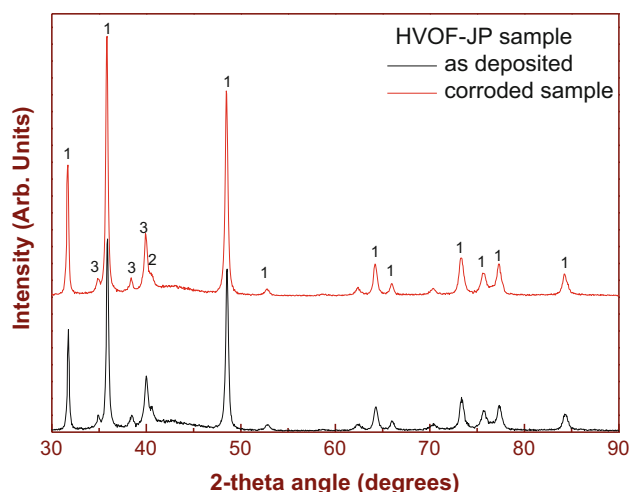
In the plane-view SEM micrograph (Fig. 10a), the preferential attack of the binder matrix by the corrosive media is revealed. The attack on WC grains is minimal (Fig. 3b). It is probable that a galvanic cell is created between the two areas that result in the accelerated corrosion of the matrix as noted in previous sections. Moreover, in some areas (Fig. 10b) there was also some evidence of removal of the WC. EDS on these areas revealed the presence of high oxygen concentrations (average 20 at.%) together with Na and Cl (average 8 at.% for each one).

Fig. 10 Plane-view SEM micrograph of the corroded HVOF-JP sample (a) and magnification of the denoted area (b)

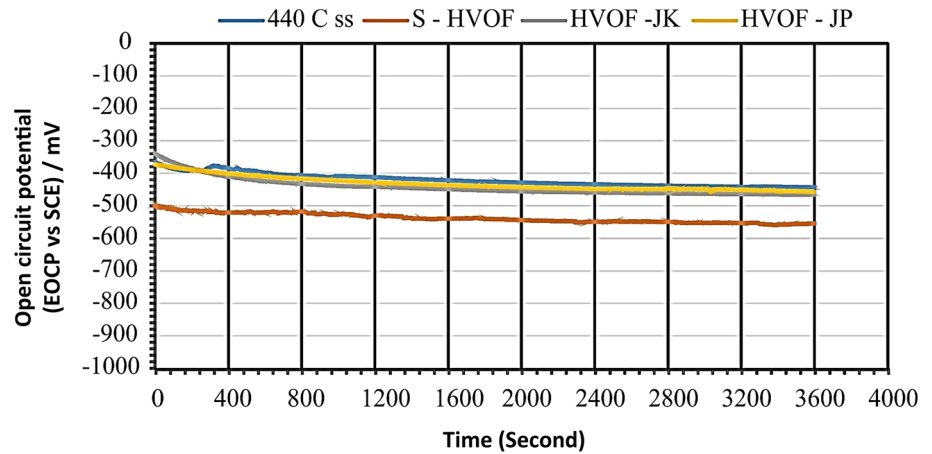
The open-circuit potential (OCP) of coated and uncoated samples (versus SCE; saturated calomel electrode) in 3.5 wt.% NaCl aqueous solution during a period of 60 min is shown in Fig. 12. OCP measurements stabilize after ~ 30 min of exposure. It can be seen (Fig. 12) that compared with 440C stainless steel ($E_{\text{OCP}} = -443 \pm 10$ mV) all coated samples had more electronegative values (for S-HVOF, $E_{\text{OCP}} = -550.3 \pm 20$ mV; for HVOF-JK, $E_{\text{OCP}} = -466 \pm 10$ mV and for HVOF-JP $E_{\text{OCP}} = -457 \pm 10$ mV) with the most electronegative E_{OCP} reported for S-HVOF-coated samples. These measurements show that the coated samples (especially S-HVOF coating) are more active (or anodic) in comparison with the stainless steel substrate. This indicates that the substrate is nobler than the coatings, and thus, taking only thermodynamic considerations, the coating corrosion will most likely occur in preference to the substrate when the substrate and the coating are in electrolytic contact.

Fig. 12 OCP measurements of S-HVOF-, HVOF-JK- and HVOF-JP-coated samples together with the bare substrate (440 C stainless steel substrate)

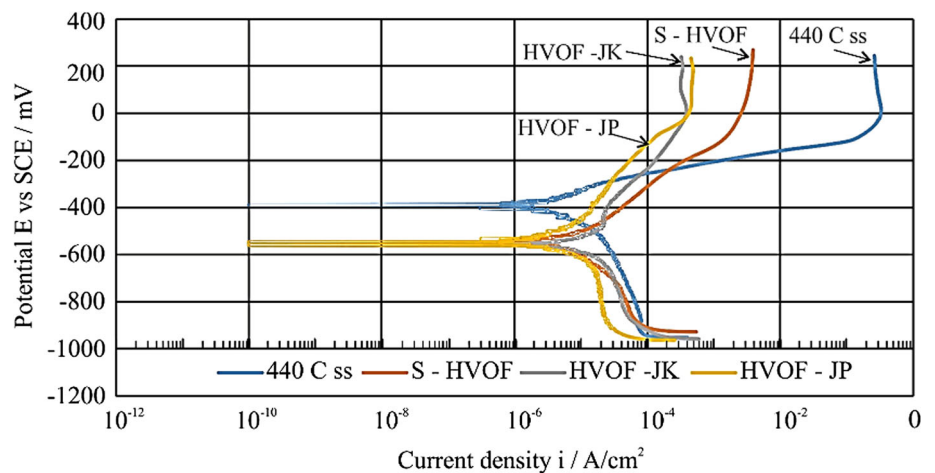
The potentiodynamic polarization diagrams of coated and uncoated samples are presented in Fig. 13. In the cathodic part of the polarization curves, two regions can be observed that probably represents (1) the mass transfer dominated reduction of dissolved oxygen in the solution and (2) the charge transfer controlled evolution of hydrogen from the aqueous media at more negative potentials. The corrosion potentials (E_{corr}), corrosion currents (i_{corr}) and Tafel slopes (ba, bc) of S-HVOF-, HVOF-JK- and HVOF-JP-coated samples together with the bare stainless steel substrate 440C are summarized in Table 3. These parameters were estimated by taking into consideration several zones from 50 to 200 mV (away from E_{corr}) to optimize the fitting of the Tafel slopes. The E_{corr} values (Table 3) of the coated samples are more electronegative compared with the relevant E_{OCP} values, meaning that the substrate is nobler than the coatings. Furthermore, i_{corr} for

rises and at a potential of ~ -100 mV versus SCE the current begins to stabilize whereas at ~ 0 mV versus SCE a stable corrosion current density value is reached, possibly due to the formation of a stable oxide layer. As for the coated samples, the entire anodic region is an active dissolution region, without the existence of a pitting potential, reaching a relatively steady corrosion current. Anodic reaction products cannot enter the solution faster, and mass transfer limited current density is reached (Fig. 13).

Fig. 13 Potentiodynamic polarization measurements of S-HVOF-, HVOF-JK- and HVOF-JP-coated samples together with the bare substrate (440C ss)

From the potentiodynamic polarization measurements, it was found that the corrosion current densities i_{corr} of 440C stainless steel and HVOF-JK- and HVOF-JP-coated samples have similar values (Table 3). It should be noted that since no microcracks or large surface-connected pores can be observed as mentioned in Section “[Microstructure Before Corrosion Test](#)” for coated samples, the polarization plots (Fig. 13) possibly reveal the intrinsic corrosion resistance of the coatings. Based on this assumption, it can be suggested that the corrosion performance of coated samples is mainly affected by microgalvanic phenomena that occur between two distinct phases, existence of distinct grain boundaries and the presence of pores in the coating (Fig. 1 and 2). In plain WC-Co coatings, WC grains act as cathode (since in artificial seawater WC grains are almost inert) in contact with Co, which acts as anode (oxidation of Co: $\text{Co} = \text{Co}^{2+} + 2\text{e}^-$) (Ref 28).

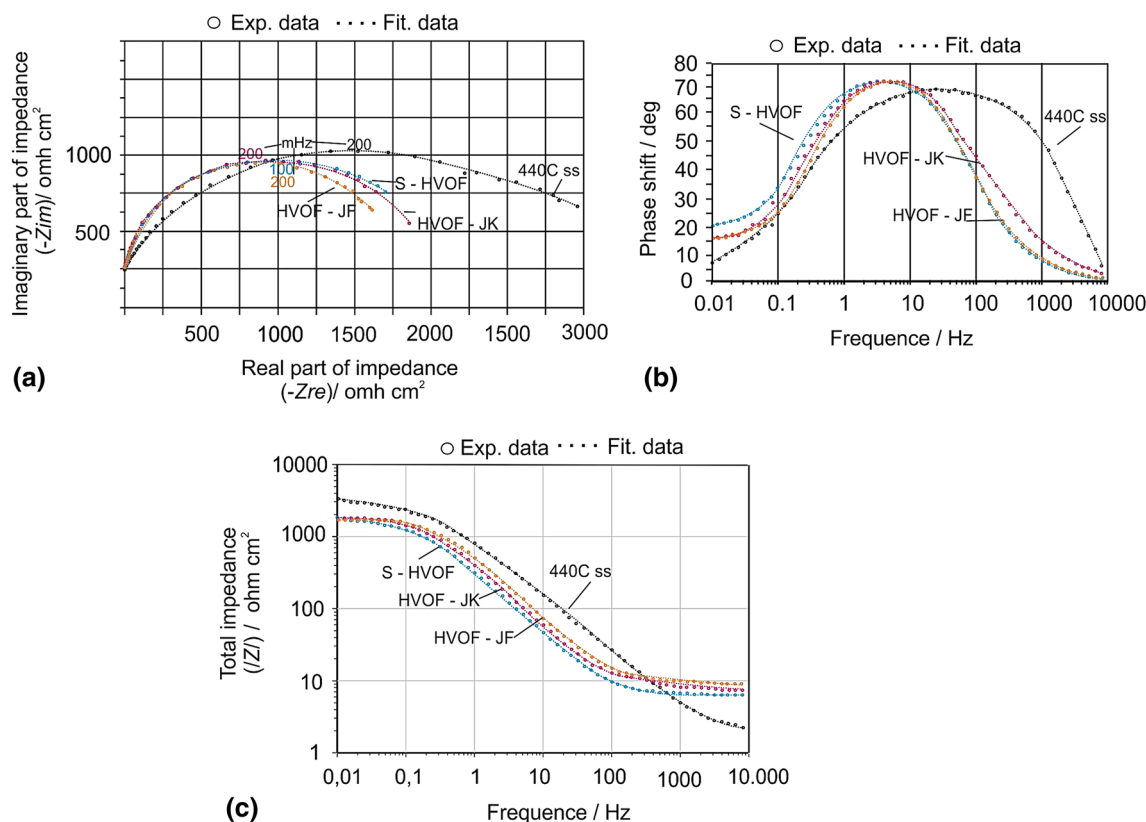
Fig. 14 (a) Nyquist plots, (b) Bode plots and (c) total impedance–frequency plots for S-HVOF-, HVOF-JK- and HVOF-JP-coated samples together with the bare substrate (440C ss) obtained after

60 min of immersion in 3.5 wt.% NaCl aqueous solution at $\sim 25^\circ\text{C}$. Z_{im} and Z_{re} are imaginary part and real part of complex impedance, respectively, whereas $|Z|$ is the impedance meter of complex number

The absence of a non-perfect semicircle at very high frequencies (Fig. 14a) can be attributed to the frequency dispersion and the absence of any continuous surface film on the specimens (“Corrosion Test Results”). Furthermore, the presence of maximum two time constants at Bode diagrams (Fig. 14b) may be related to the presence of WC grains which provide additional interfaces on the surface of the coated samples. The increase in the total impedance at low frequencies for all specimens reaching a dc limit is an indication of a complete lack of diffusion mechanism and the presence of localized corrosion (Ref 43).

Based on the resulted impedance curves (Fig. 14) and the previous results and discussion, two equivalent circuits (Fig. 15) were chosen in order to describe the early stages of corrosion of 440C stainless steel (Fig. 15a) and coated samples (Fig. 15b) in 3.5 wt.% NaCl aqueous solution. This equivalent circuit seems to offer the most coherent physical interpretation of the results having the minimum possible electrical elements.

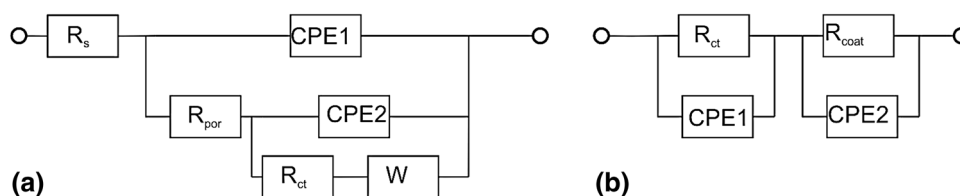
Fig. 15 Equivalent electrical circuit representing the corrosion behavior of (a) the bare substrate (440C ss) and (b) S-HVOF-, HVOF-JK- and HVOF-JP-coated samples after 60 min of immersion in 3.5 wt.% NaCl aqueous solution at $\sim 25^\circ\text{C}$

The adopted equivalent circuits for the 440C stainless steel consist of the following (Fig. 15a):

1. a resistance R_s of electrolyte solution,
2. a charged transfer resistance R_{ct} , which characterizes the polarization of the specimens–solution interface due to the formation of an electric double layer inside any reacted area,
3. a Warburg (W) resistance Z_w related to the diffusion direction of oxidants to any formed electric double layer,
4. an impedance Z_{CPE1} of a constant phase element $CPE1$ (or $CPE3$) that characterizes the capacitance C_c of any oxide layer (or product's layer) on the 440C stainless steel,
5. an impedance Z_{CPE2} of a constant phase element $CPE2$, which characterizes the capacitance contribution C_{dl} of any formed electric double layer on the interface between specimens and the solution inside any corrosion area,
6. a resistance R_{por} that describes the solution resistance which appears within any formed pit on the surface of any specimen.

1. a charged transfer resistance R_{ct} , which characterizes the polarization of the specimens–solution interface due to the formation of an electric double layer on the interface between specimens and the solution inside any corrosion area. An increase in the value indicates that the increase in corrosion resistance of passive films occurs due to either film thickening or compositional modification in the corrosive environment,
2. an impedance Z_{CPE1} of a constant phase element $CPE1$, which characterizes the capacitance contribution C_{dl} of any formed electric double layer on the interface between specimens and the solution inside any corrosion area,
3. a resistance R_{coat} that describes the resistance of the coating,
4. an impedance Z_{CPE2} of a constant phase element $CPE2$ that characterizes the capacitance C_{coat} of the coatings on the 440C ss substrate.
